# Manhole Inspection Summary

Manhole # S35SS1002MH

**Location** Address: **5119 UNDERWOOD RD**

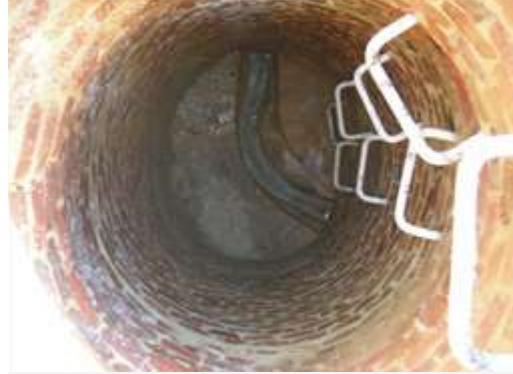
Top View

☐ Parged ☒ **Debris** (not Condition related)

Bench debris.

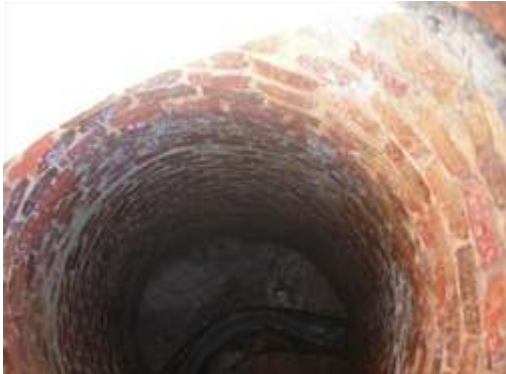
Defect

Infiltration: ☐ None ☒ **Joint** ☐ Cracks ☐ Mortar ☐ Roots ☒ **Wall**

Adjustment and Barrel infiltration.

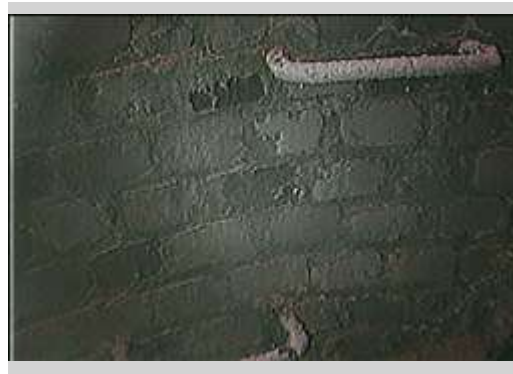
Defect

Infiltration: ☐ None ☐ Joint ☐ Cracks ☐ Mortar ☐ Roots ☒ **Wall**

Barrel infiltration.

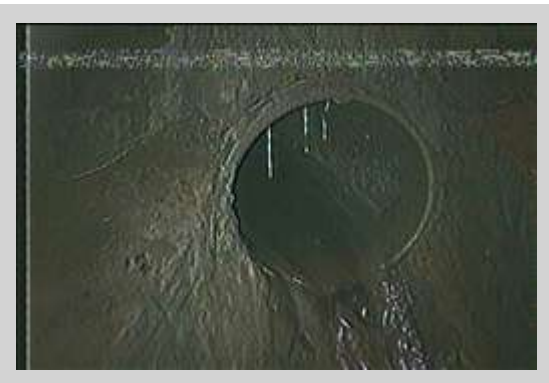
### 8 in. Circular Gravity Sewer Pipe In @ 4 O'Clock

Infiltration: **None** Pipe Seal Cond: **Cracked**
